# ROLE OF VERY FAST TRANSIENTS IN HV TRANSFORMER BUSHING FAILURES AND ITS REMEDIAL MEASURES

## II. DETAILS OF FAILURE INVESTIGATION

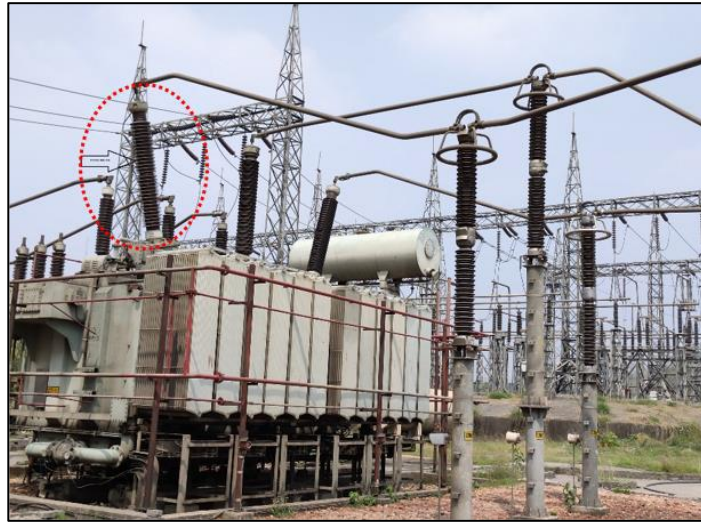
interconnecting transformer got failed at Jharkhand, India in the season of winters and in the month of November as show in figure 1. Failure was noticed as 220 kV/132 kV 250 MVA transformer got tripped due to differential protection and Buchholz trip.

Figure 1: Site photo depicting tilted R-phase failed HV transformer bushing.  
Source: Author, (2026).

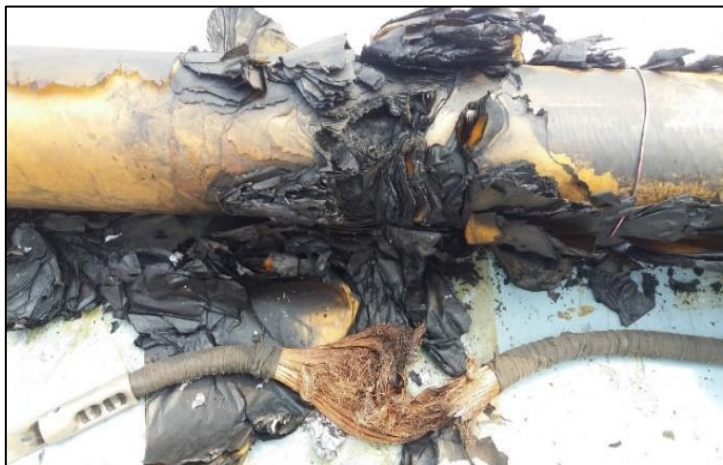
Figure 2: Failed 245 kV Condenser bushing with displaying a failed Draw Lead in the bottom of the picture.  
Source: Author, (2026).

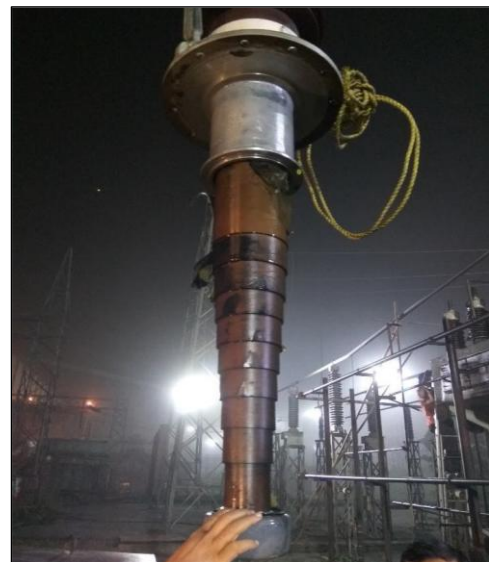
Figure 3: Site photo depicting tilted R-phase failed HV transformer bushing.  
Source: Author, (2026).

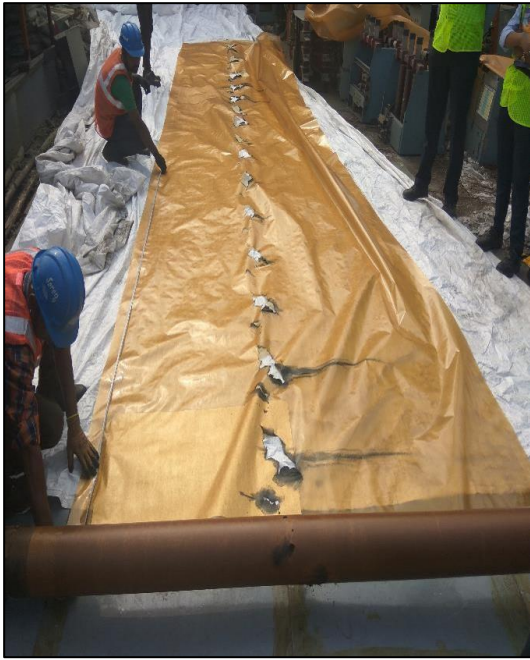
A visual examination of failed bushing components was carried out as shown below in figures 2 to 5. The bushing was dismantled and insulation layers were unwound carefully as shown in figure 4. The tap portion was found intact, and no burn of flashover was observed in this region. Insulation paper was found burnt almost at the center of the bushing. All the damage was localized at that location as shown in figure 2. Burn marks were seen only on top layer of insulation throughout the length of the bushing. Except at the burn portion (at center) all internal layers were found normal. The draw lead was found to have burnt strands and got open circuited (almost 70% strands open) as seen in figure 2. The burnt lead position coincides with the burnt paper location. The burnt portion is nearly one foot above from the lead joint. Insulating paper layers were removed gradually. Oil traces were found in all layers throughout the length of the bushing, indicating that bushing was not dry in any region during its service. Aluminum foils used for voltage grading were found to be intact at all locations and hole size was gradually reduced as observed during unwrapping. A hole of 2cm diameter approximately was found on the aluminum tube as shown in figure 5. The burnt location coincided with the burnt copper strand location in the draw lead. The aluminum tube was cut open at the fault region for closer internal examination.

Figure 4: Radial Breakdown of bushing paper near the bushing flange.  
Source: Author, (2026).

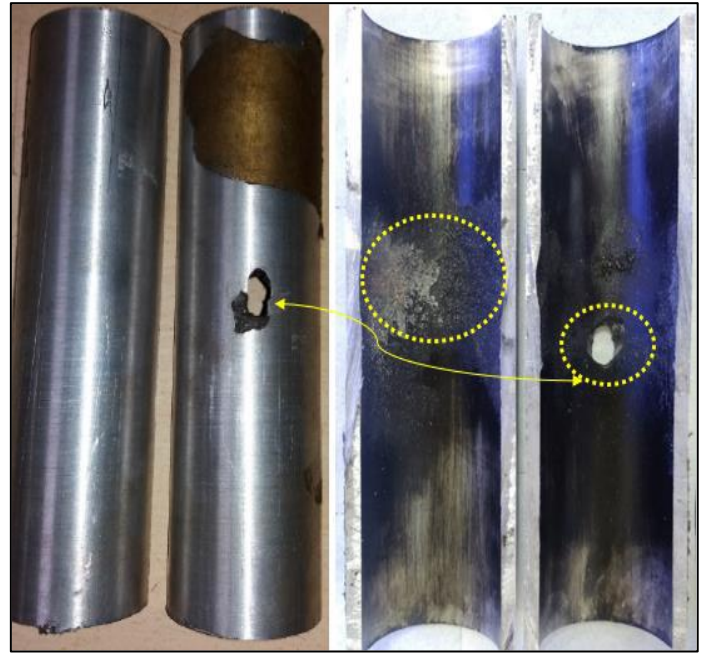
Burn and overheating/pit marks, were seen all around the tube inside. Reduction in thickness was observed in a few locations, similar to prolonged overheating. Internal of the rest of the tube was found normally by visual examination as well as in borescope inspection. During the process of removal of the defective bushing from the transformer, it was seen that the bottom porcelain had broken and fallen inside the tank. There were superficial burn marks and cuts on the bottom paper insulation as shown in figure 3. The top cap of the bushing got dislodged from its cementing portion and hot oil/gases escaped from it. Burnt paper was projecting out of the top opening. R phase winding lead clamps, holding the winding lead between the winding exit and the bushing, were found broken and the lead was found freely moving. There were signs of pressure at the lead exit point and the strands got disturbed from the original location and the paper insulation was found torn.

Figure 5: Burn marks inside the AL tube.  
Source: Author, (2026).

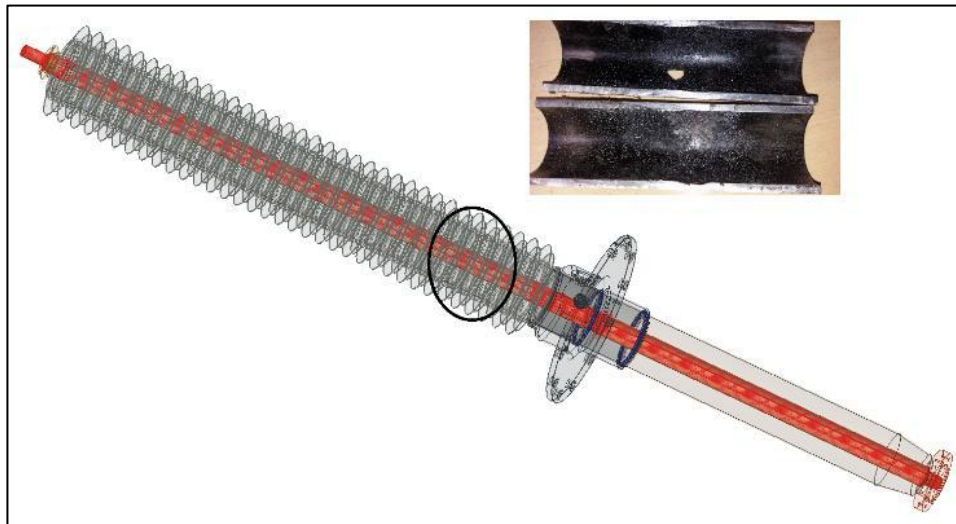
Figure 6: Fault location inside condenser bushing.  
Source: Author, (2026).

Failed aluminum tube showed presence of fracture void near the flange along the thickness of tube as shown in figure 6. Internal view of tube showed rough surface (melted region) opposite the fracture void surface.

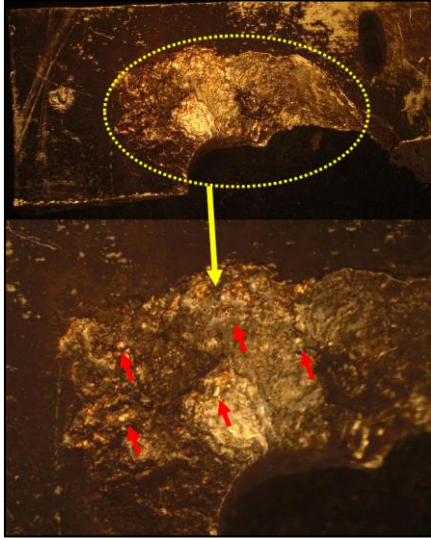
Macroscopic examination of surface near the fracture void indicated the presence of shiny orange particles (melted copper attached to the aluminum tube surface) as shown in figure 7. Void formed due to melting of copper strands opposite to fracture surface and the droplets of fluid copper flowed into the aluminum tube. Grooves were observed when seen from the cross-sectional view of the fracture void which was due to liquid flow of the copper droplets. Fracture void was seen at an inclination along with the thickness of the fracture which was due to the installation of bushing at an inclined angle as shown in figure 8.

Figure 7: Macro structure of void of aluminum tube with zooming of cross-sectional surface (6x magnification).  
Source: Author, (2026).

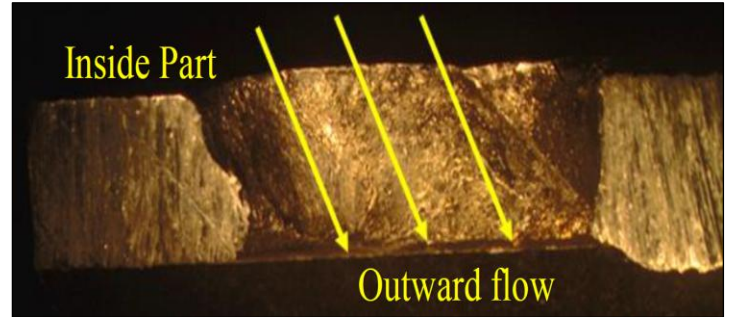
Figure 8: Macro structure of void of aluminum tube with zooming of cross-sectional surface (6x magnification).  
Source: Author, (2026).

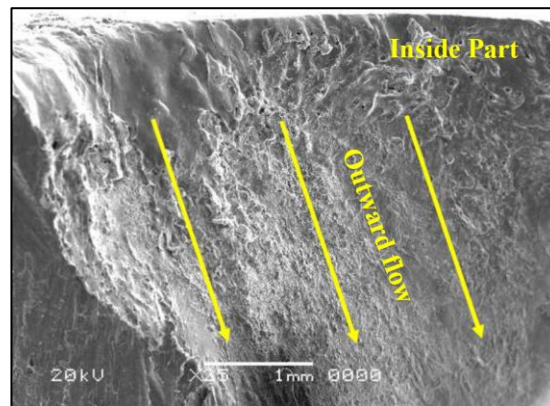
SEM micrographs of rough region showed smooth appearance region with lot of porosity. It also showed presence of smooth melted and solidified portions on rough surface. Inside fracture void region, it showed groove lines along the thickness which was formed due to hot copper liquid flow. No signs of prolonged overheating of aluminum tube and the draw lead conductors.

Figure 9: SEM of fracture surface of void present on aluminum tube.  
Source: Author, (2026).

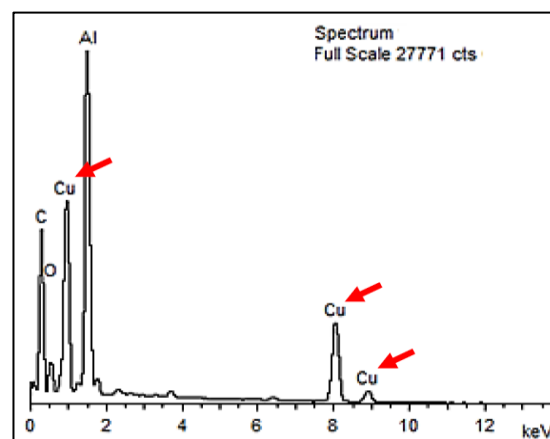
EDS analysis of shiny orange particles present in rough surface and melted region was carried out to confirm the composition. EDS confirmed the presence of copper in melted regions of aluminum.

Figure 10: EDS image in rough surface and melted region in the void.  
Source: Author, (2026).

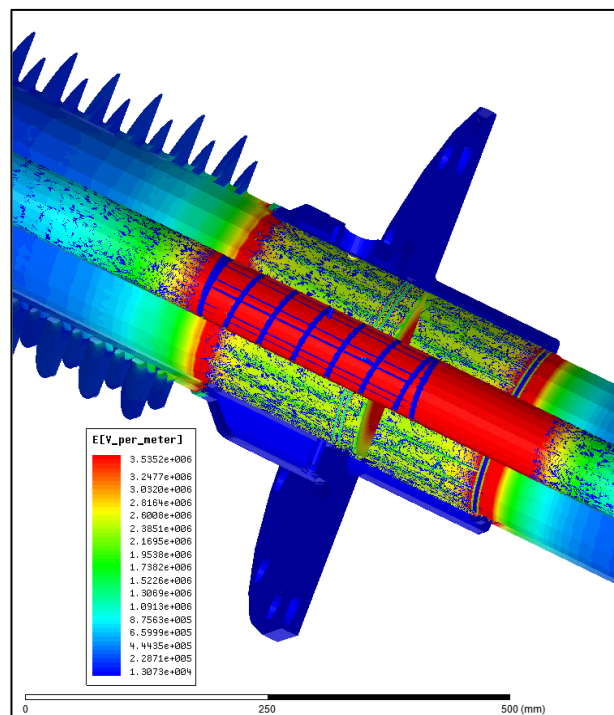
Figure 11: Electrical Stress Distribution (cross-section).

Ground potential is applied to flange area, and 245 kV voltage has been applied to HV conductor as a known potential. Electrical stress is seen maximum near the flange area.

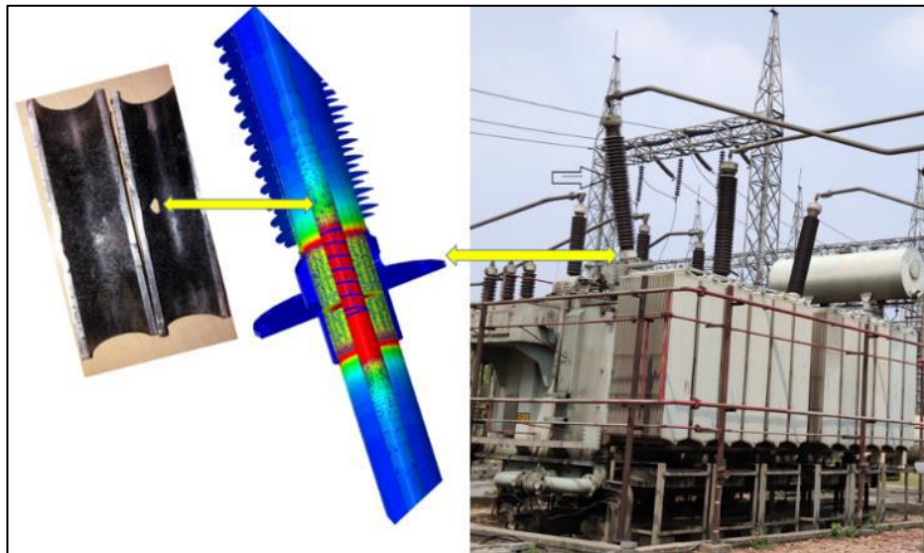
Normally the VFT ends at the terminals but in this case, due to the 'in-between contact' of tube and draw lead near the bushing flange, VFT ended at the in-between contact near the bushing flange which created a punch hole type fracture void in the aluminum tube [6]. Melting of copper strands clearly shows that temperature inside the aluminum tube might have gone above 1085°C (Melting point of copper). Due to cooling being difficult in the flange region, intensive thermal degradation was seen near that region only and not causing harm to any other areas. Consequence was finally a radial breakdown near the bushing flange. This clearly showed how an incipient failure of HV transformer developed into a terminal failure. However, analysis of bushing oil after failure could not be carried out due to non-availability, which may have provided us with additional information about the presence of arcing and overheating.

Figure 13: Failure Mechanism in presence of VFT.

Improving the dielectric strength of the insulation between the copper draw lead and the central aluminum tube will help to minimize the risk of such failure scenario. 1 mm of thermally upgraded insulation between the draw lead and central tube should be suggested to the manufacturer for such type of flexible conductor design for titled bushings. This would ensure that there is no ‘in-between contact’ between the draw lead and aluminum tube which provides sufficient ‘in-between’ insulation during such sudden rise in voltage drop situations from top to bottom of the bushing [5]. The most effective in-service mitigation measure for this failure scenario is bushing thermal image scanning [7]. When a problem is suspected (especially in the case of draw flexible lead with tilted bushings), DGA (bushing oil – if appropriate) may provide additional information about the presence of any arcing or overheating [8], [9].
