WATERPROOFING APPLICATIONS IN MASONRY STRUCTURES: A CASE STUDY OF RESIDENTIAL BUILDINGS IN THE NORTHERN ZONE OF MANAUS, BRAZIL

ABSTRACT

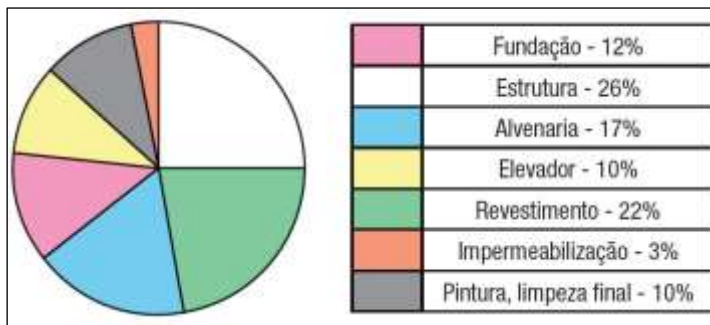
Figure 1: Estimation of the cost of waterproofing on a project.
Source: Authors, (2025).

Despite its critical function, waterproofing is often undervalued, both in financial and technical terms. As shown in Figure 1, waterproofing typically represents only around 3% of a project's overall cost, a proportion that belies its crucial role in ensuring durability and habitability over time. This low investment often results in higher costs later due to repairs, maintenance, or legal disputes with property owners.

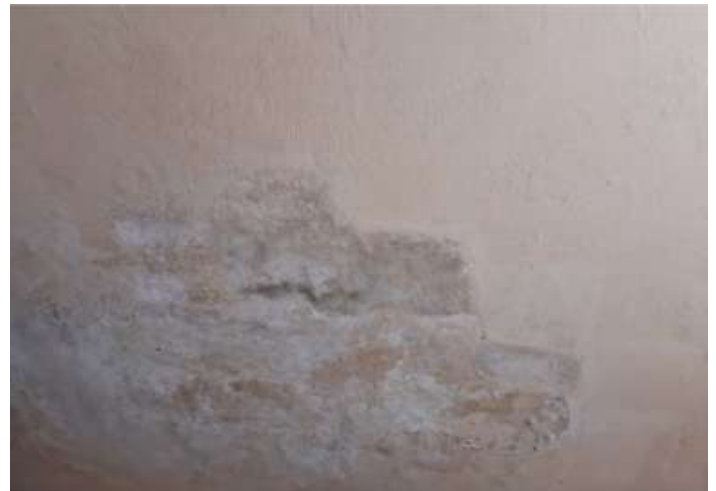
Figure 3: Appearance of efflorescence on the masonry wall.
Source: Authors, (2025).

Among the visible consequences of infiltration is efflorescence, which presents as white crystalline deposits of salts (mainly calcium carbonate) on the surface of walls or floors. These deposits indicate chronic moisture penetration and are often accompanied by internal pressure caused by salt crystallization,

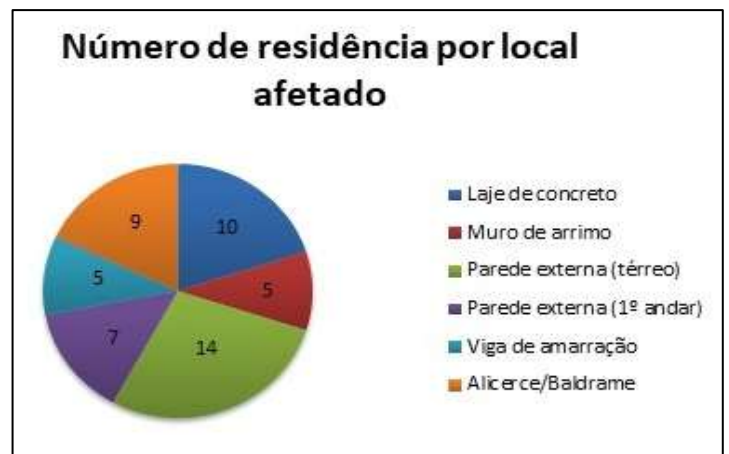
Figure 5: Number of residences per pathology-affected area.

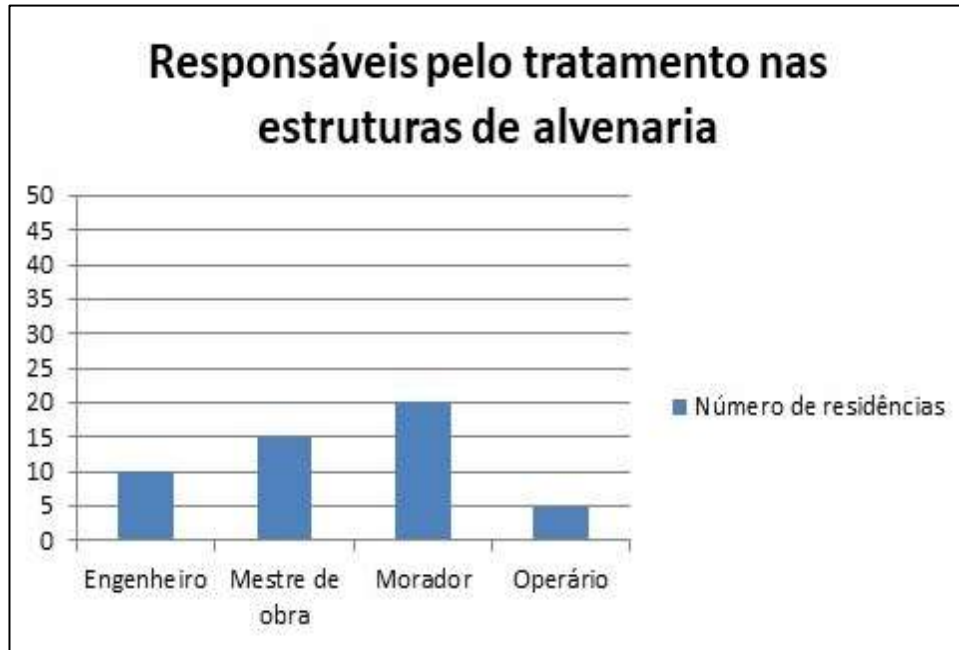
Figure 6: Parties responsible for residence construction. Source: Authors, (2025).

Figure 5 illustrates the profile of those responsible for constructing the surveyed residences, revealing that homeowners predominantly executed or supervised the work. This reality

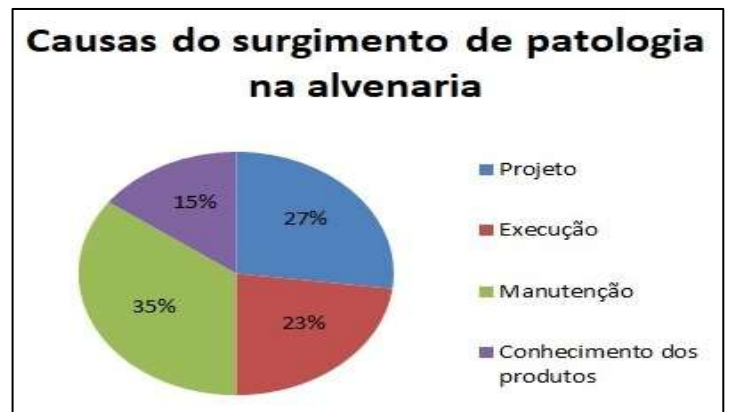
Figure 7: Root causes of pathologies in surveyed residences. Source: Authors, (2025).
