## GEOTECHNICAL AND NUMERICAL ANALYSIS OF SLOPE STABILITY: CASE STUDY OF BESSA, ALGERIA

Abdelhalim Bensaada<sup>1\*</sup>, Abderahman Younsi<sup>2</sup>, Razika Zaoui<sup>3</sup> and Elbahdja Sid<sup>4</sup>

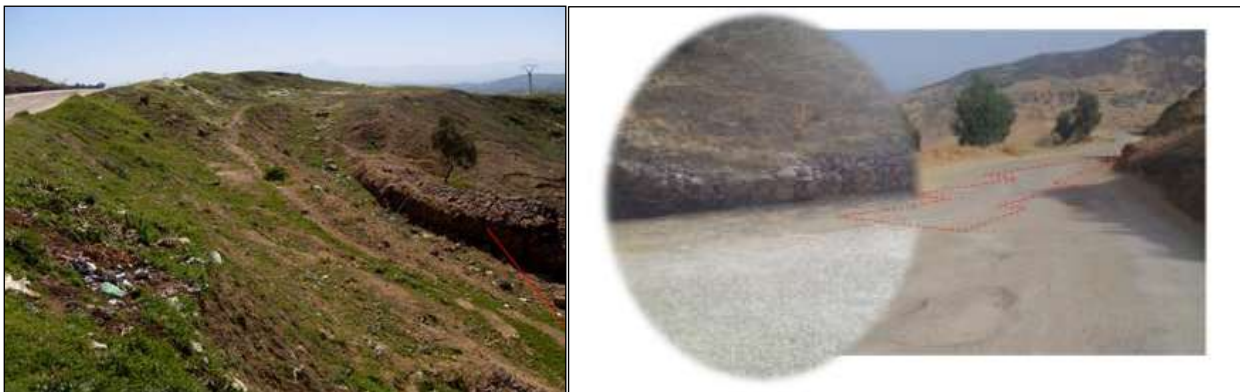
Figure 2: Field photographs showing surface disorders and slope deformation along the affected road section.

Field inspections revealed that the studied road section is affected by several forms of distress, including longitudinal and transverse cracking, as well as significant subsidence of the embankment-side shoulder. These deformations indicate progressive slope movement and localized rotational sliding along the embankment. The most pronounced instabilities were observed at four critical points where the roadway margins have displaced laterally (Figure. 2) The damage intensified during the rainy season, suggesting a strong correlation with increased pore-water pressures and reduced shear resistance in the clayey embankment material. Morphological analysis indicates that the observed failures are primarily controlled by interstitial water pressure developing at the interface between the embankment fill and the natural slope. The instability of this section can be attributed to several aggravating factors:

- Accumulation of pore-water pressure due to the absence of an adequate subsurface drainage system;
- Poor anchorage and limited toe support of the downstream slope;
- Deficient surface drainage (blocked culverts and deteriorated concrete ditches);
- Steep natural slope angles along the road alignment.

Overall, these factors collectively promote loss of stability during periods of high rainfall, leading to partial slope failure and progressive deformation of the roadway embankment.

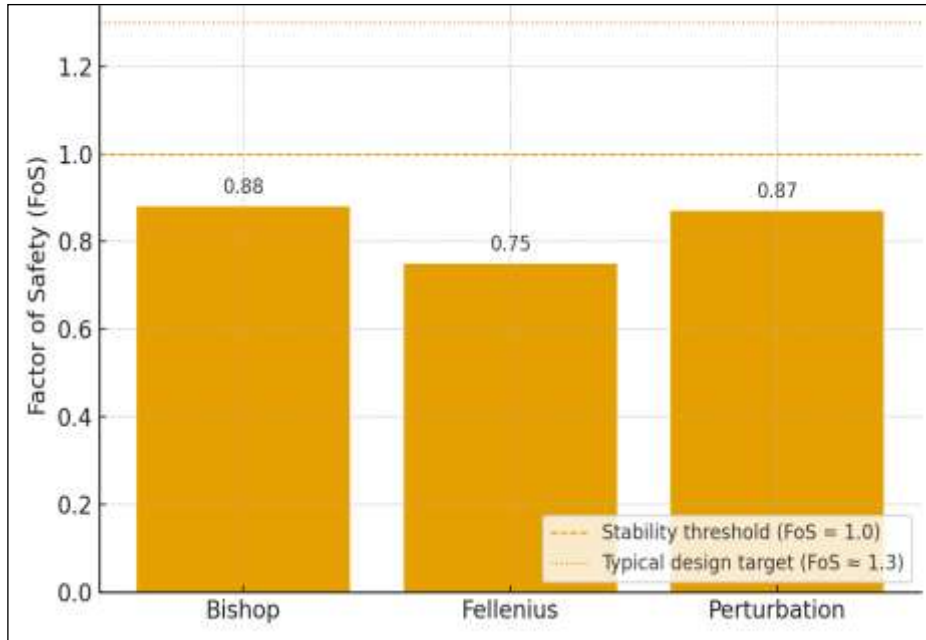
Figure 6: Variation of computed factors of safety by method showing unstable condition ( $FoS < 1.0$ ).

The results show that the failure mechanism is controlled primarily by the low-strength yellowish–brown clay layer, where low cohesion and moderate friction angle coincide with elevated pore pressures. The critical slip surface is shallow to medium depth, extending through the clayey embankment and terminating at the interface with the stiffer marly clay. Considering the seismic loading (Zone IIB,  $a_h = \pm 0.15g$ ,  $a_v = \pm 0.0375g$ ), FoS values remain well below the minimum acceptable design criterion ( $FoS \geq 1.3$ ). This confirms that the slope is unstable under both static and seismic conditions, requiring immediate drainage improvement and structural reinforcement to achieve long-term stability. Implication. Given  $FoS < 1.0$  across methods (and further reduction under adverse  $k_v > 0$  combinations), stabilization measures are required. The next section presents drainage improvements, slope reprofiling, and localized structural reinforcement sized to raise FoS to acceptable code levels.
