## ITEGAM-JETIA

Manaus, v.6 n.24, p. 53-57, July/Aug., 2020

## INFILTRATION: THE DISEASE OF THE STRUCTURE

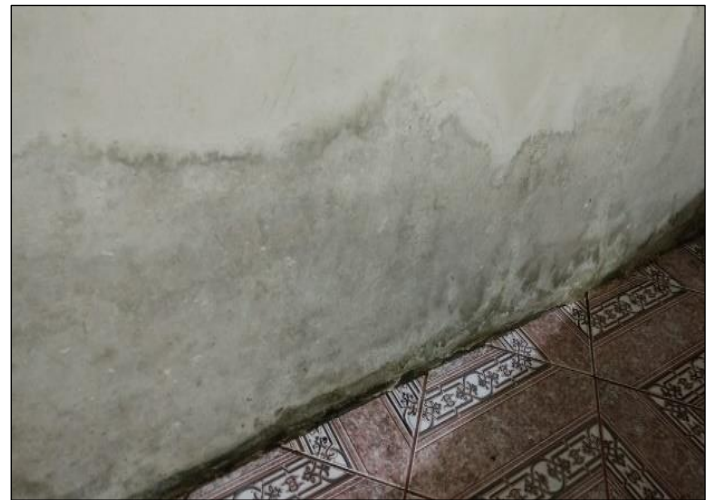
In the Figure 1, shows a pathology found in a building in the city of Manaus, AM. It was identified that the wall is in parallel with the ground. This causes water to percolate from the soil to the inner side of the wall and can manifest diseases caused by the accumulation of fungi.

Figure 1: Wall with pathology caused by capillarity.

The action of water by capillarity is visually perceived, as it causes the appearance of spots in the regions usually close to the ground, accompanied by mold spots, cryptoflowering, efflorescence or parasitic vegetation, especially in places with poor ventilation.

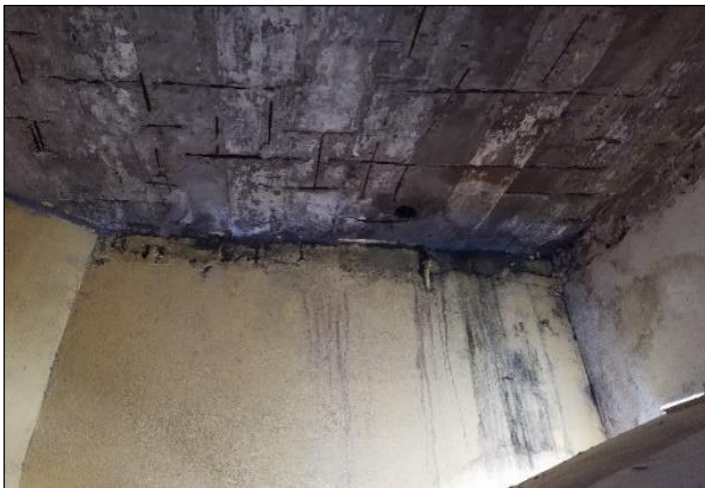
The humidity as it increases, causes an expansion of the material, and when it decreases the contraction is proven. Hygroscopic changes influence the deformability characteristics of masonry, as they cause the dimensional changes they perform (Figure 2). Volumetric variation can cause cracks, and is similar to those caused by shrinkage [14].

Figure 2: Infiltration in reinforced concrete slab.  
Source: Authors, (2020).

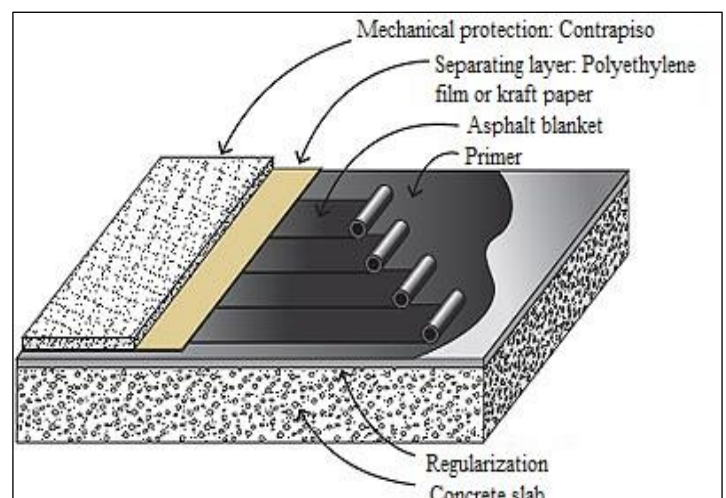
Figure 3: Waterproofing of asphalt blanket on a slab.  
Source: Adapted of [20].

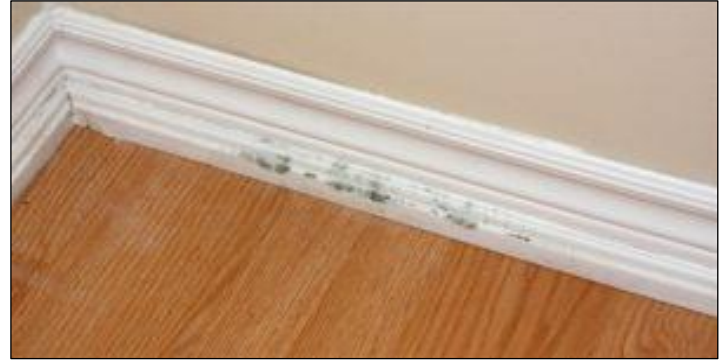
Figure 5: Mold infecting the object.  
Source: Authors, (2020).

Mold and mildew have differences. Mold erodes the affected material and mold infects the object. They are housed in closets, clothes, walls and furniture.

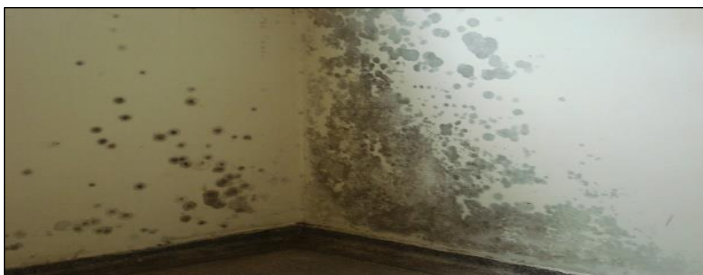
Figure 4: Wall mold caused by moisture.  
Source: Authors, (2020).

In addition to the infiltration damaging the structure with mold and mildew, it can cause residents respiratory diseases. Mold and mildew are caused by fungi that proliferate in humid environments, caused by poor ventilation, infiltration and by closed environments.
