# DELAMINATION STUDY WHEN DRILLING ON A CARBON C-ORTHOCRYL COMPOSITE USED IN ORTHOPEIDIC PROSTHESIS

c-orthocryl,  
Delamination,  
Drilling,  
SEM,  
CFRP.

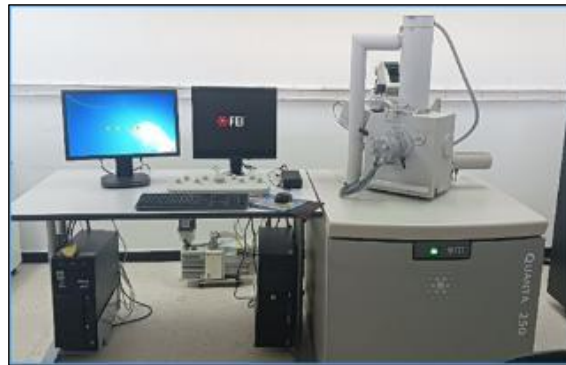
Figure 3: SEM electronic microscopic Quanta 250.  
Source: Authors, (2026).

To achieve an absolute understanding of delamination during the drilling of this composite, SEM analysis with assistance (Machine MEB) was performed. Specimens were carefully cut from the drilled area of all holes using an HSS twist drill to ensure minimal marks were generated during cutting and provide a clear imaging surface. or image acquisition, a Quanta 250 In Fig. 3, SEM images were acquired in black scattered electron, the SEM images were treated using TrackerLab, the images were converted to grayscale, and the ellipse mask was applied to the region of interest.

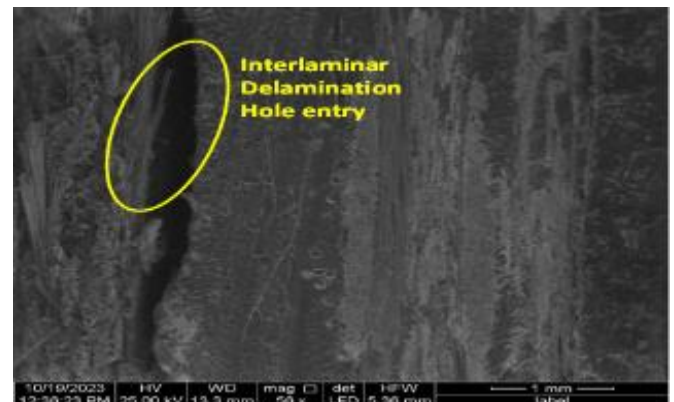
Figure 6: SEM Image for frontal plane hole entry at 56 X  
Source: Authors, (2026).
